Caution!

Applies To

This advisory involves platform towing safety, and applies to all Wills Wing gliders manufactured with keyhole tang nose catch systems, which is almost all models introduced since the fall of 1981.

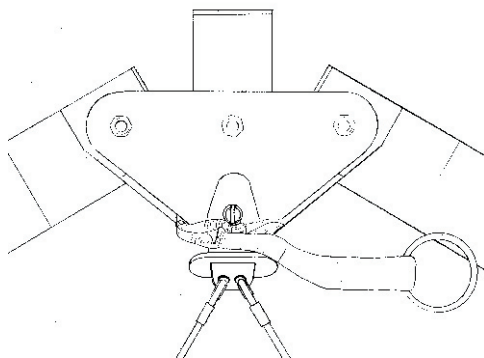
CORRECT

In June of 1989, Wills Wing published an advisory regarding this potential safety problem, including diagrams showing a suggested correct routing for a nose line and one example of an incorrect routing. These diagrams are reproduced here. The critical consideration is that the nose line must be routed in such a way that there is no possibility that the line can push or pull forward on the tang, the tang handle, or the wires. This advisory and these diagrams were incorporated into subsequent glider owner’s manuals for the HPAT, Spectrum, Super Sport, and XC glider models

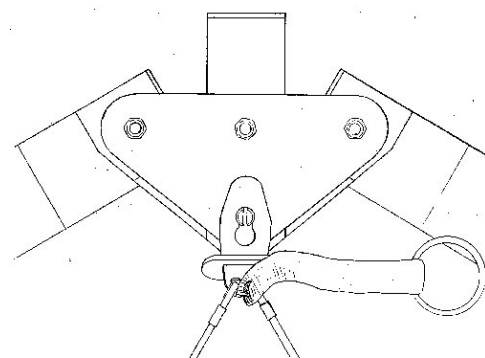
WRONG - UNSAFE

Recently, a pilot was seriously injured when the nose wires on his Wills Wing Fusion became detached during a platform tow launch. Preliminary information indicates that the tow system nose restraint attachment line was routed behind the nose tang and in between the wires. Because the nose line, when routed this way, pulls down on the keel and simultaneously forward on the tang, there is a very high likelihood that the keyhole nose tang, unless otherwise restrained, will be disconnected from the nose of the glider. The nose line will hold the wires in place until the nose line is released, which may make this problem difficult to detect prior to the actual launch of the glider. Without the nose wires attached, the pilot will have no pitch control of the glider, and, upon release from the tow vehicle, the glider will typically climb sharply, stall, and dive to the ground.

Please note that it is not sufficient merely to insure that the line is routed outside the “V” of the nose wires – it must also not be routed behind the tang handle, or in any way that it can pull forward on the tang.

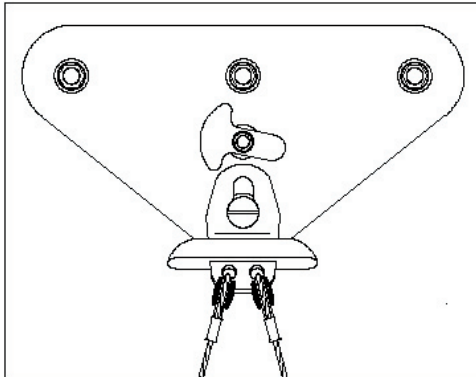
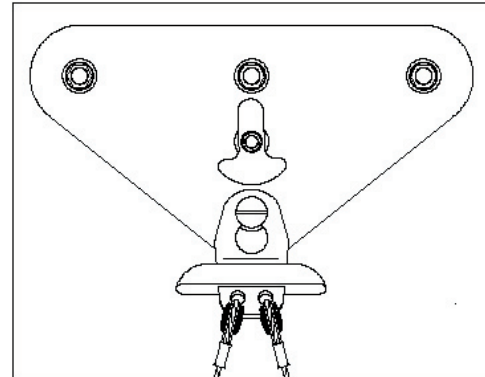
In June of 1991, following a second incident of this type, we redistributed the advisory, adding the warning that routing the line outside the “V” of the wires but behind the tang handle could also result in disconnect of the wires. In August of 1991, we began manufacture of a pivoting locking device to prevent the keyhole nose tang from being pushed forward and disconnected. The “keyhole anchor lock” is shown in the diagrams below. This locking device was incorporated into all production gliders and made available for retrofit for all existing gliders using this hardware system.

We do not have record of any incidents of this type following the adoption of the locking device, prior to this most recent accident. Preliminary investigation of this recent accident has not been able to establish conclusively whether the locking device was engaged or not prior to the start of the tow during which the wires became disconnected. However, experiments by those investigating the accident on site, which have been repeated by Wills Wing, have indicated that it is possible that a swiveling action of the nose tang during the ground roll prior to launch could cause the safety lock to be rotated to a position that would allow the wires to subsequently disconnect on release of the glider from the truck. It therefore cannot be assumed that the safety lock will prevent the nose wires from being disconnected if the nose line is routed between the wires or behind the tang handle.
