All recently manufactured hang loops for kingpost hang models.

Inspect and replace as necessary.

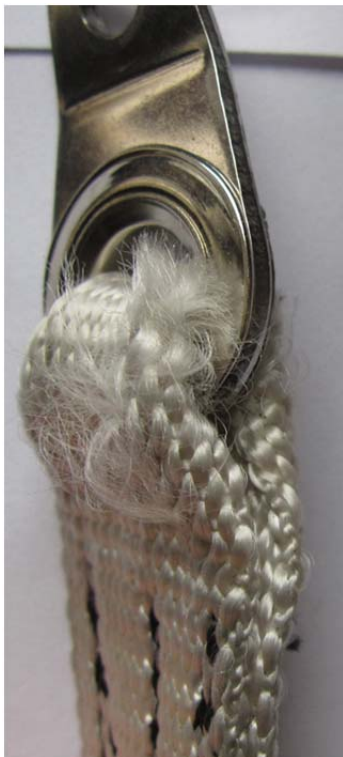
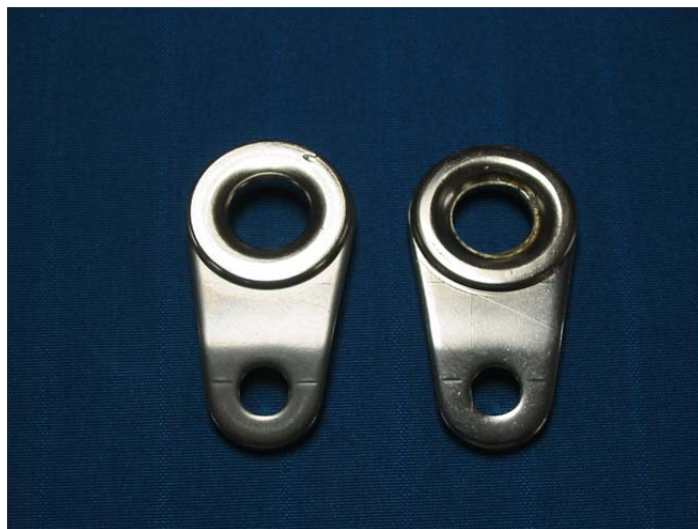
A customer recently discovered greatly accelerated wear on a hang loop where the loop attaches to the tang which is bolted to the kingpost on a U2 145. Current production models that use this type of hang loop are all U2's and all Sport 2's. Recently manufactured replacement hang loops for other models using a kingpost hang system are also affected by this inspection – recall notice. We do not know the exact time period to which the recall applies, but we know at least one defective loop was produced as early as March of 2011, so we recommend inspections of all loops made up to 6 months prior to that.

We have determined that the accelerated wear is likely caused by a defective grommet installed in the hang loop tang which is the result of a damaged grommet setting tool. The photo on the left below shows the damage to the hang loop, and the photo on the right shows a correct grommet – tang installation on the left, and a defective installation on the right, where there is a sharp edge on the inside of the installed grommet.

Inspect the hang loop carefully for any sign of wear at the attachment to the tangs, and inspect the grommets installed in the tangs for any sharp edges. If you find wear on the hang loop, or sharp edges on the grommet, the hang loop will need to be replaced.

If your hang loop needs to be replaced, contact your Wills Wing dealer or Wills Wing directly to obtain a replacement loop. You will need to provide your glider serial number, model and size, and if your loop is not a standard Wills Wing length loop, you will need to provide the distance from the clip in point on the hang loop to the top surface of the basetube. (See the article here for more information on determining and specifying non-standard hang loop lengths:

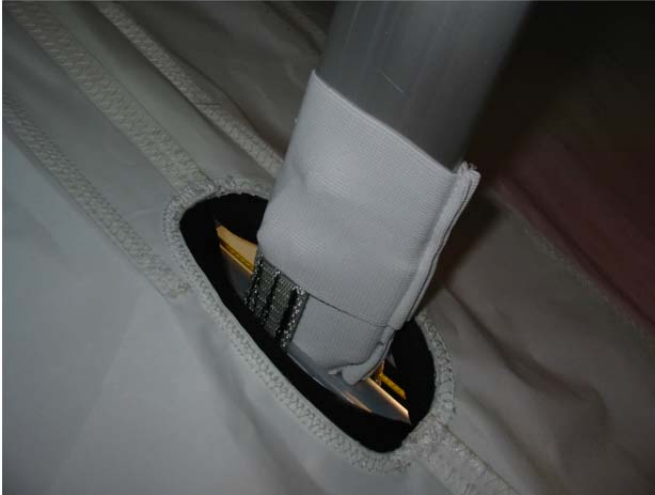
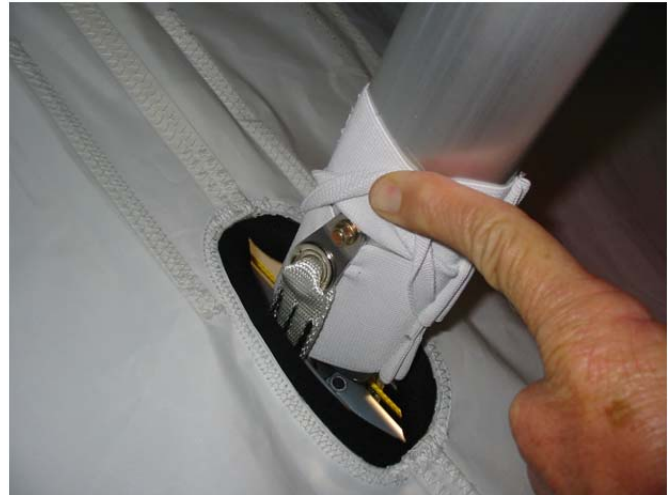
Note that there are two factors which may prevent one from noticing the defect on casual inspection – one, the hang loop tang is normally covered up by the protective kingpost base sock, and two, the defect on the hang loop tang grommet may be on the inside of the tang, not easily visible unless the hang loop is removed from the kingpost so that the inside of the tang can be inspected.

Peel back the protective sock to expose the bolt head and clinch nut that secure the hang loop to the kingpost. Remove the ¼ inch clinch nut from the bolt, remove the bolt from the kingpost, and dismount the hang loop from the kingpost. Note that there are two loose bushings inside the aluminum bushing that is permanently installed in the kingpost – take care not to misplace these.
