### Applies To:

HP AT 145 and HP AT 158 gliders delivered before July 1st, 1990.

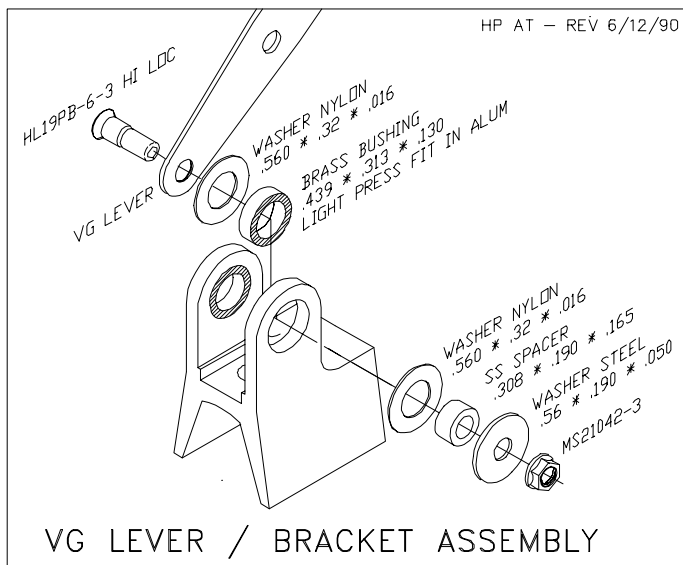
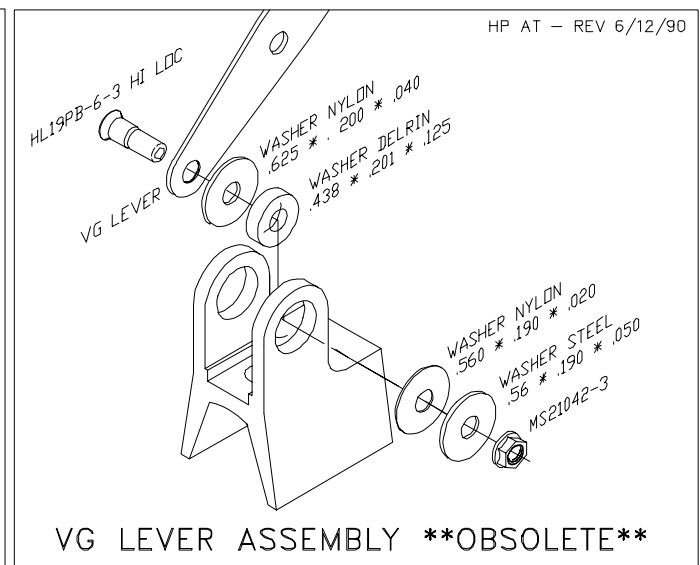
All HP ATs delivered by Wills Wing before July 1st, 1990 were produced with the VG Lever Assembly shown below in the figure labeled "Obsolete". These assemblies were subject to two maintenance problems: first, the inner delrin bushing deteriorates prematurely increasing VG activation forces and play in the lever assembly; second, the 3/16 clinch nuts sometimes loosen and fall off rendering the VG mechanism inoperable. We have designed a retrofit assembly which addresses both of these problems and is simple to install.

Disassemble the lever assembly (not shown) by drilling out the rivets holding the plates together. Discard the washers and the clinch nut shown in the "obsolete" diagram. Retain the lever handles, lever spacers and HiLocs. Reinstall the HiLoc though the lever handle, inside nylon washer and VG bracket hole (for each side). Rivet the lever handles together (with the lever spacers between the handles) through the eyelet spacers inserted in the companion handle. Align each brass bushing axially with hole in the aluminum bracket and push it into place. It may be necessary to lightly tap the bushing but be careful to avoid misalignment. Install the remaining ss spacer, nylon washer, steel washer and clinch nut. Tighten the clinch nut firmly - the spacer should prevent the handle from binding on the bushing. The finished assembly should swivel freely and independently from the bronze bushing and bracket assembly.
