RamAirs assembled between 10/19/93 and 12/19/93.

Recently it was discovered that a RamAir 154 manufactured in November of 1993 had improperly fabricated rear leading edges. The clevis pin which locates the 48mm innersleeve was mislocated, and the innersleeve itself was of the wrong length. We need to determine if this fabrication error was an isolated incident, or if other gliders were made with the same fabrication error. We have compiled a list of all RamAirs manufactured over the 60 day period from one month before this glider was made until one month after. Enclosed with this bulletin is a list of all such gliders which were sold by your dealership. We are asking you to contact the owners of these gliders, and either have them inspect the gliders themselves and report to you, or bring the gliders to you for inspection. The inspection process itself is very simple, and should not take more than five minutes. It does not require that the glider be set up or removed from the bag. Should we find that this was not an isolated incident, we will expand the inspection to include a broader range of manufacturing dates.

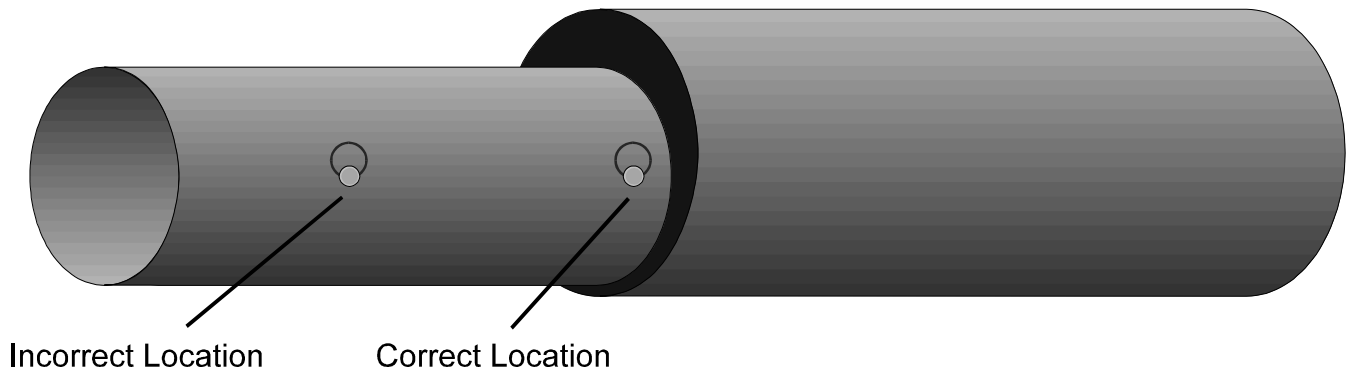
Refer to the diagram below. The clevis pin which secures the 9" long 48 mm innersleeve inside the front end of the 50mm rear leading edge spar should be located 0.5" behind the point where the 50mm rear leading edge exits from the rear of the 60mm front leading edge. (Shown in the diagram is a left leading edge - the nose of the glider is to the right - the right leading edge would simply be a mirror image.) The diagram depicts two clevis pin locations - the forward one is correct, while the rear location is incorrect. The glider will have one or the other, but not both.

- 1) Lay the glider on the ground in the bag, zipper up, and unzip the bag full length.
- 2) Feeling through the bottom surface panel of the sail, along the inside of the leading edge, find the point at about six feet forward of the tail end of the glider, where the leading edge steps down from 60mm to 50mm in diameter.
- 3) At this point, you will be able to feel the clevis pin and the small safety ring which secures it. It should be located immediately (1/2") aft of the step down from 60mm to 50mm. If instead it is located at approximately 3" behind the step down junction, then the rear leading edge is improperly fabricated, and needs to be corrected.
