Parachute Swivel

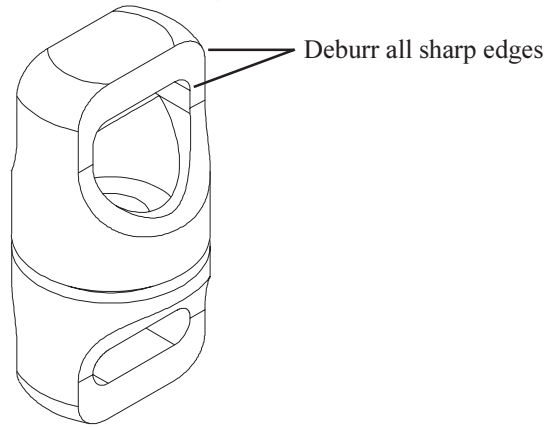
A number of early model parachute swivels were produced with sharp edges which could cut the parachute bridle webbing during a deployment. (The swivel pictured below is the later model, which is not subject to this problem). Early model swivels are aluminum colored, while later models are anodized blue. Not all aluminum colored swivels are subject to this problem, but all swivels which are subject are aluminum colored.

To inspect your swivel, pull the webbing towards the side of the slot and feel the edges along the top of the slot. If they feel sharp, you need to deburr these edges, and also the edges in the corners and on the sides of the webbing slots with a small file. It is not necessary to remove the bridle to do this. You should inspect the bridle during this process for any sign of damage.

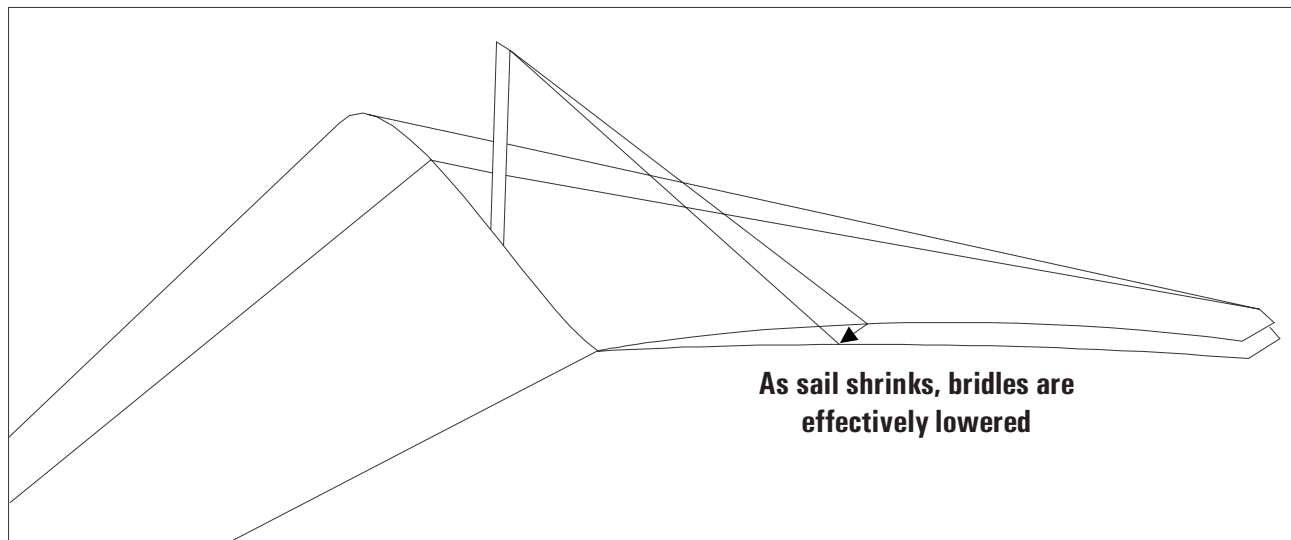
Because of this trailing edge shrinkage, proper adjustment of the bridles cannot be verified on an older gliders by measuring the distance from the top of the kingpost to the bridle attachment point of the trailing edge. This measurement will not change as the sail shrinks, even though the trailing edge will become supported at a lower height as the attachment point moves inboard.

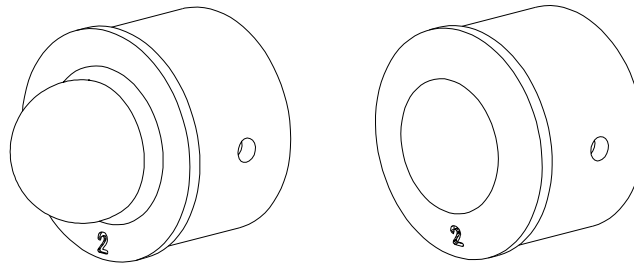
This set can be identified by a “2” stamped into the part (shown below).

These two types of ball socket joints cannot be interchanged.

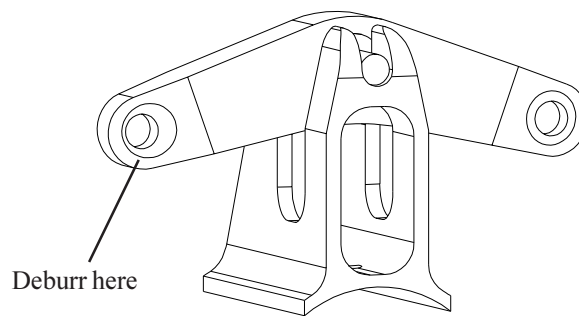
Fusion Type 1 Hang System

The first Fusions used a four strand 7mm accessory cord main hang loop tied with a grapevine knot (as illustrated in the Fusion Owner's Manual). There are two service related concerns with this loop:

- 1) We have had reports of wear on the sheath of the accessory cord where it passes through the hole in the spreader bar.
- 2) We have had reports of the hot knifed end of the accessory cord cutting through the load bearing strand of the accessory cord.

Fusion main hang loops of this type must be carefully inspected. If any wear is apparent, the accessory cord must be replaced. If wear is apparent where the cord passes through the hole in the spreader bar, this area of the spreader bar must be thoroughly de-burred to remove any sharp edges.

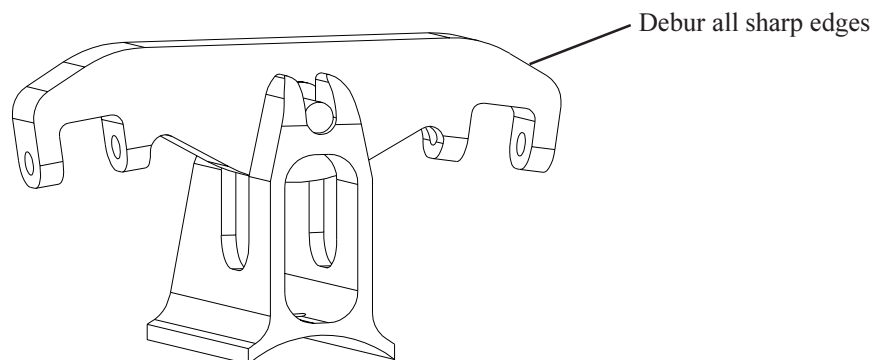
Fusion Type 2 Hang System

The current Fusions feature a webbing loop mounted to a newly designed spreader bar. The early spreader bars were machined with edges which were not adequately broken in the machining process, and which are unacceptably sharp. As a result, it is possible that during transport of the glider, the loop can be cut or abraded by contact with the spreader bar. Spreader bars of this type on gliders assembled prior to July 7th 1997 must be inspected for sharp edges and carefully de-burred as necessary. Replace any hang loop showing any sign of wear or damage.

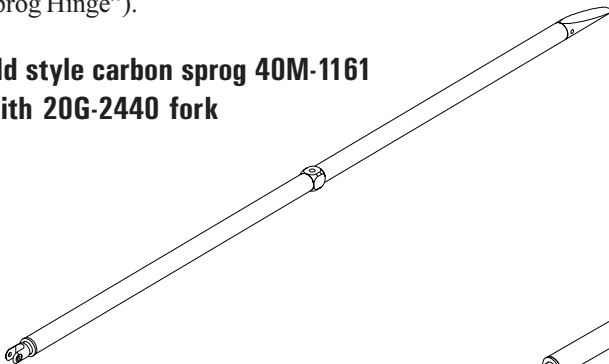
**Old style carbon sprog 40M-1161
with 20G-2440 fork**

Over the past year, we have encountered several different types of service related failures of Fusion sprog assemblies. As a result, we have made several changes to the sprog design since the initial product release to improve maintenance and durability issues. Most recently, we have completely redesigned the sprog assembly (see below). Since the sprogs are concealed in the sail, and can be deployed without inspection, it is possible for significant damage to remain undetected. It is essential that Fusion owners regularly perform the inspection procedure detailed below.

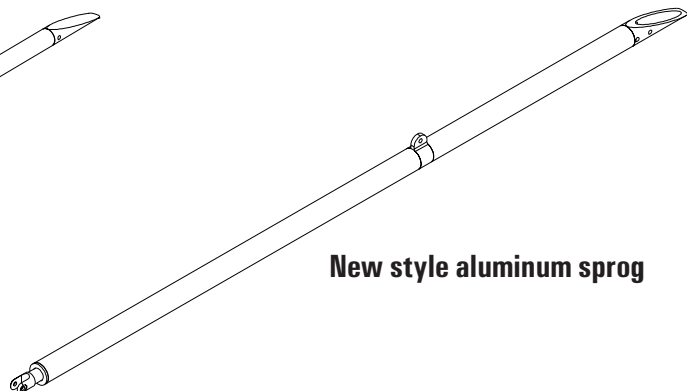
New style aluminum sprog

All Fusions manufactured after June of 1998 will be made with a new sprog design, utilizing a new, all 7075 aluminum tube, a new center fitting, a new rear paddle, a new cable, and a new threaded insert and stainless steel threaded fork. These parts, taken together as an assembly, with the addition of a longer bolt to mount the cable to the leading edge bracket, are backwards compatible with all earlier Fusions. In addition, the new threaded sprog fork is backwards compatible with the earlier carbon reinforced sprog tubes (if the original threaded insert is undamaged).

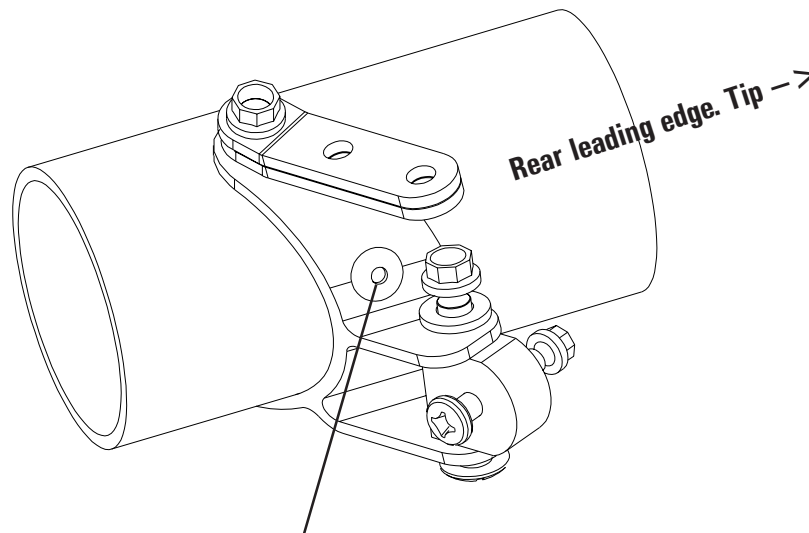
Recently, a Fusion owner performing a routine pre-flight inspection reported that the rivets which secure the orientation of the sprog bracket to the back of the leading edge tube were sheared off. The rivet is essential to the structural integrity of the sprog assembly. The cause of the rivet failure is unknown.

Inspect rivet center for retained mandrel. Replace rivet if mandrel is missing or recessed more than 1/16 inch below surface of rivet dome

Refer the diagram below. Inspect the rivet fastening the bracket to the backside of the leading edge tube. The 3/16 diameter rivet (part number 10R-0366 Rivet AL 3/16 x .350 Cherry AAPQ6-4) is a high strength 'retained mandrel' type. If the mandrel is missing or the mandrel end is recessed more than 1/16 inches (.063) below the rivet head, the assembly should be considered unairworthy until the rivet is replaced. Replacement rivets are available without charge from Wills Wing. Please include 'Reference TB980709' and your glider number with your request.

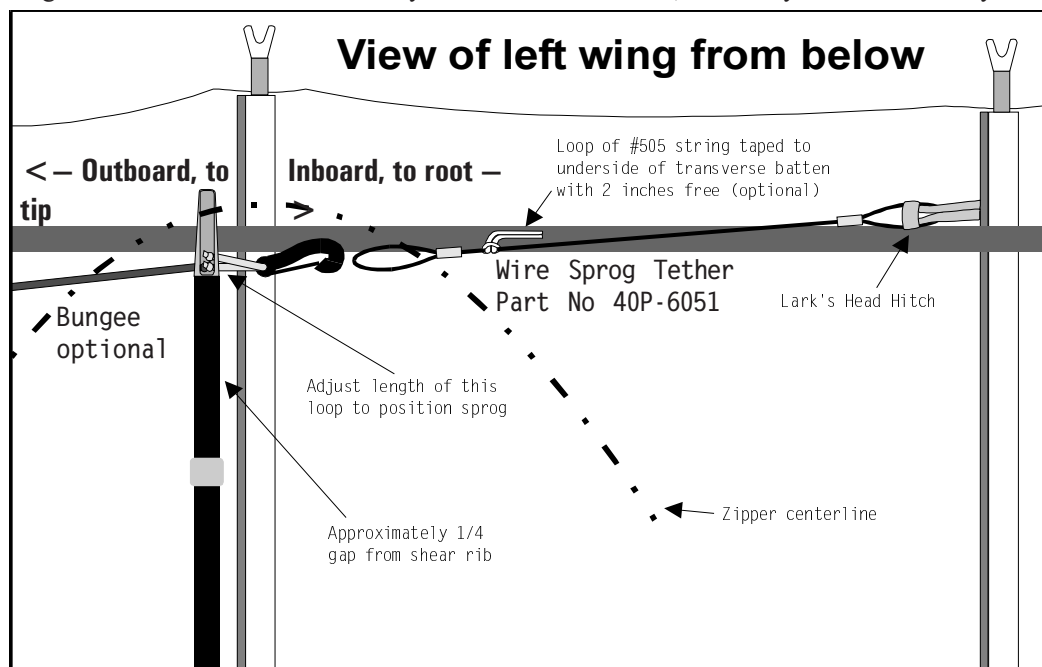
Note: Due to the small diameter of the cable, it can become disengaged from the snap clip if there is any gap between the hook and gate on the clip. Inspect the clip periodically, and if you notice a gap, adjust the clip as follows:

1. Pull the gate laterally to the side of the hook, and then outward $\frac{1}{4}$ " to $\frac{3}{8}$ " away from the hook.
2. Re-position the gate inside the hook, and verify that it is completely closed.
3. Press the gate inwards as would be necessary to disconnect the cable, and verify that it closes fully when released.

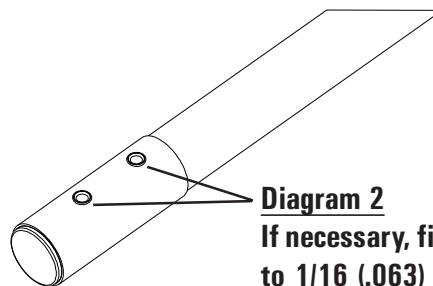
Diagram 1
Nut should have 1 full thread engagement beyond untapered portion of bolt shank. Dimension shown corresponds to 1/4-28 thread.

Diagram 2
If necessary, file bushing heads to 1/16 (.063) above tube

1. Remove washers, or substitute thin washers for thick washers.
2. Use a flat file to reduce the height of the heads of aluminum bushings to 1/16” (.063”) above the tube.
3. Replace the bolt with a longer bolt.

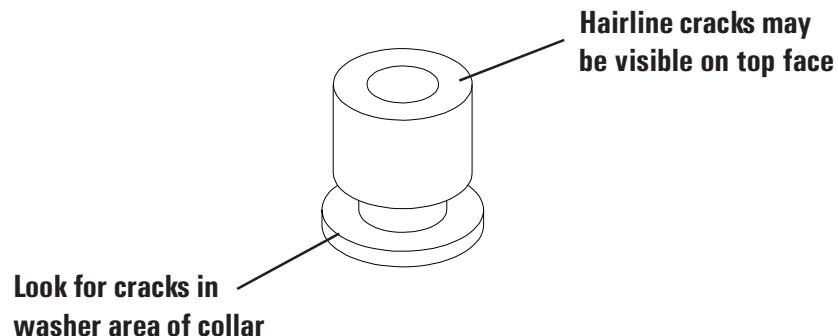
Keyhole Collar

Recently we have seen three incidents of partial failures of this collar. The nature of these failures has ranged from cracks appearing in the part, to a separation of part or all of the “washer” area of the collar from the remainder of the part. In one case, the failure of the collar was coincident with, though apparently not the cause of, the nose wires becoming detached from the noseplate. (The apparent cause of both the wires becoming detached and the failure of the collar in this incident was the fact that the nut which holds the collar on came off of the bolt. See TB# 980716 for more information on this.) As near as we can determine, even a complete, catastrophic failure of the collar would not allow the wires to become detached in flight, so long as the nut remains in place, as either the nut or the head of the bolt (depending on the configuration) would retain the keyhole tang.

However, in our investigation of these incidents we have determined that the part as manufactured is unacceptably brittle, and can be expected to be subject to some probability of failure in normal use. We are therefore recalling all of these parts, and requiring their replacement. We have manufactured new parts out of a different, stronger and less brittle material. The new parts can be distinguished by the color of the plating. The original parts are gold colored 'Cad II' (the same as most AN bolts). The new style replacement parts are silver colored 'Cad I'.

Replace both keyhole collars on your glider with new ones. You may obtain new ones through your dealer, or direct from Wills Wing. Please supply the model and serial # of your glider. Note that Falcon 225's use a slightly different collar on the rear keel; it has a wider necked area to accept two keyhole tangs. We will supply parts at no charge on a warranty basis for any gliders manufactured within the last year. We will make the collars available for \$1.50 each (normal retail price is \$3.00 - \$4.50) for gliders more than one year old.

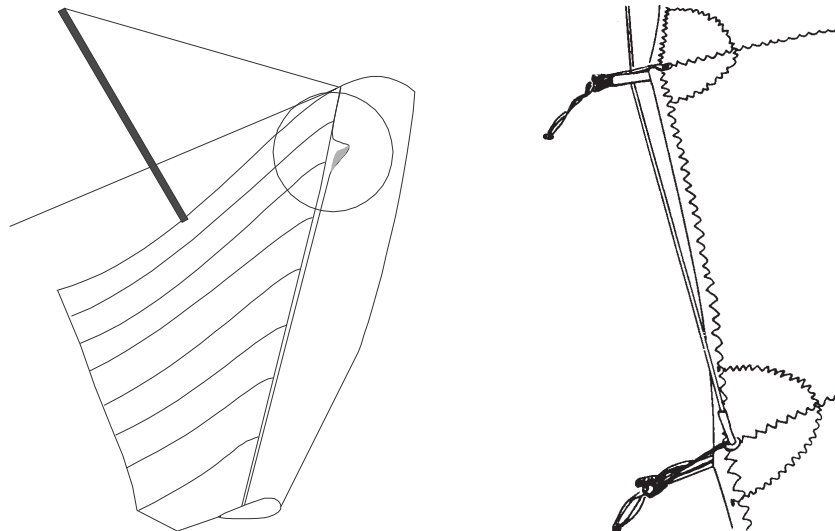
Distorted Mylar Insert And Bridle Cable Snagged Under A Batten

While inserting the battens during set up of the glider, it is possible for the tip of the batten, acting through the sail, to catch the rear edge of the mylar leading edge insert, pushing it forward and folding it under in the process. This will cause a raised area of discontinuity in the mylar pocket portion of the leading edge of the wing, which in turn will cause a significant disruption of the air flow. The air flow can be affected over a wide area both inboard and outboard of the actual distortion. The result is that the affected portion of the wing will stall prematurely, at a higher airspeed and lower angle of attack than normal. Consequently, the glider will be difficult to control in the normal minimum sink airspeed range, will tend to stall repeatedly if flown in this speed range, and will tend to fall off into a diving turn towards the affected wing. The glider will exhibit delayed recovery from the stall, and the pilot will experience unusual negative pitch pressures in the control bar.

It is possible during set up that a bridle cable may end up passing underneath the rear end of the next inboard batten. Because it causes the cable to follow other than a direct route to its attachment at the kingpost, this significantly shortens the effective length of the bridle cable. If this condition is not corrected during pre-flight inspection, the cable will pull up hard on the trailing edge in flight in the vicinity of the batten under which it passes. This will cause the glider to trim slower than normal, and possibly in a stall. It will also cause a turn towards the affected wing, and it will cause the glider to be generally less responsive in roll, and more difficult to control.

The primary and preferred solution to either of the above problems is to avoid them by always performing a proper pre-flight.
