Applies To

U2 – all sizes
Sport 2 – all sizes

Introduction

Wills Wing Technical Bulletin

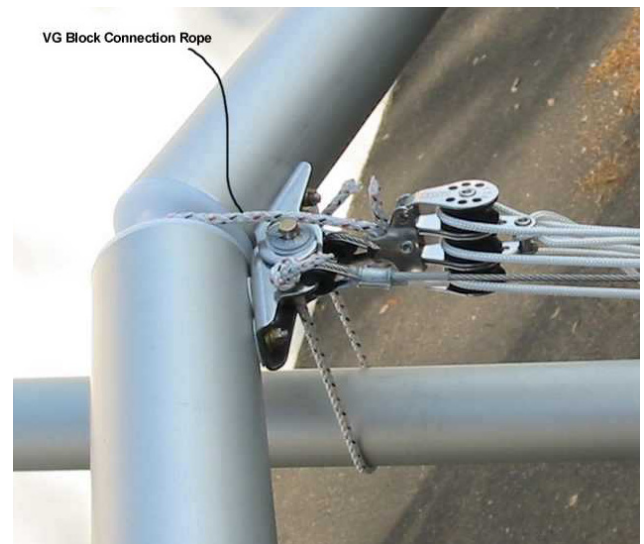
On the U2 and Sport 2 gliders, the forward pulley block for the VG system is anchored to the xbar center ball by a short loop of rope.

On gliders assembled prior to June of 2005, the rope used was a single loop of 4mm Super Pre-Stretch, (as shown in the photo above) and it was secured with a square knot (as illustrated below).

We recommend an upgrade of this rope connection on all gliders to the current configuration, detailed below. Regular subsequent inspection and periodic replacement of this rope is also necessary to preclude the possibility of an in-flight failure of this rope connection. When the VG is set to other than the full loose adjustment, this rope is under significant tension, and this tension increases as additional maneuvering loads or gust loads are placed on the glider in flight. If this rope were to fail in flight, the crossbar would move forward unrestricted, until the sweep wire became tight – thus placing a shock load on the sweep wire. Although we have received no reports

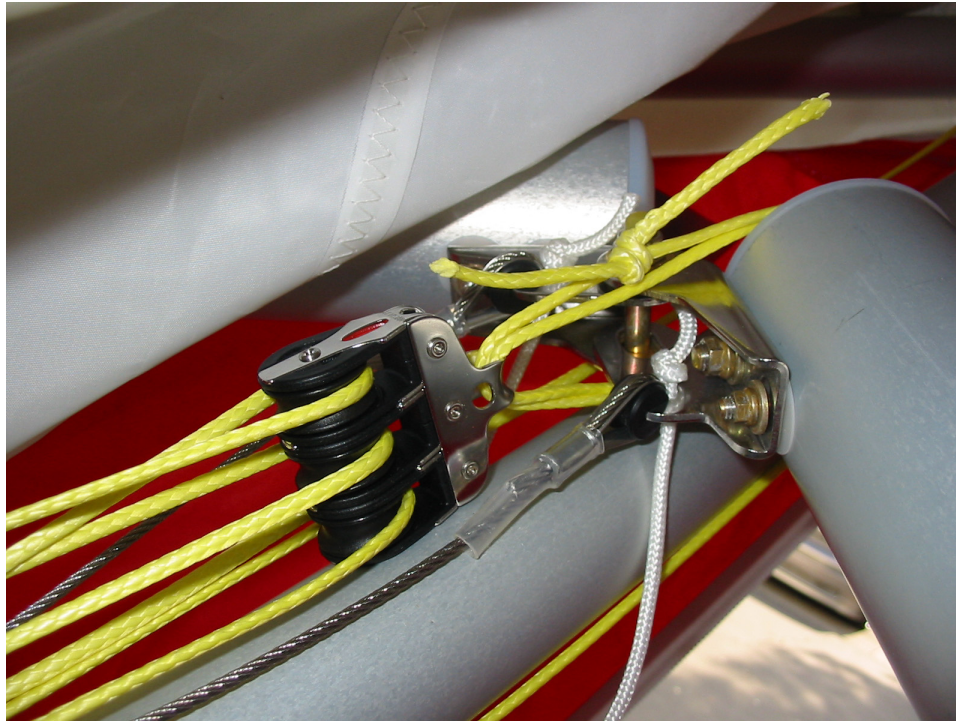
We are currently using 30J-3012 CORD - 3MM OC3-3Y YELLOW in this application. This material is more resistant to wear than is the 4mm Super Pre-Stretch, however it also has a slicker surface. Gliders on which this material was used that were assembled prior to May 15, 2007 used a single loop of this rope to make this connection, secured with a fisherman's knot. Testing of this type of loop has shown that under high loads, the knots may gradually slip. As a result, we are now using a double loop of this material, as shown.

We are recommending that all Sport 2's and U2's be upgraded to the double loop of 3MM OC3-3Y YELLOW cord, and that all such gliders, even subsequent to this upgrade, be inspected on a regular basis for any sign of wear on the rope and to insure the integrity of the securing knots.

To replace the rope, simply cut off the old rope and install the new one. Pass one end of the rope down through the bracket on the pulley block, then upwards through the hole in the xbar center ball, down again through the bracket, and then up through the ball a second time, following the routing as shown above, and bringing the two free ends of the rope together above the keel center between the ball and the pulley block.
