Parachute Swivel

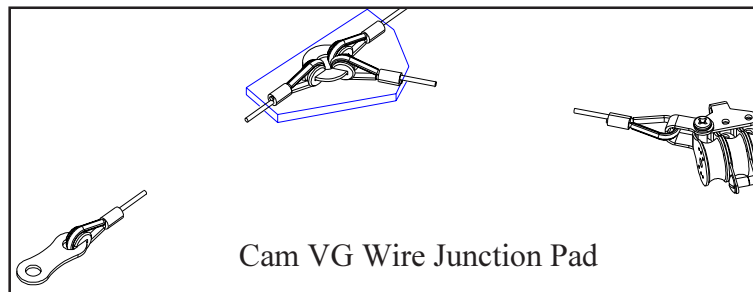
Wills Wing has designed a neoprene pad for the cam VG wire junction on Fusions to protect the sail and airframe from damage during packing and transport. If you own a Fusion manufactured before November 1997, you may request a free retrofit pad set for your glider.

- 1) The pad system on new Fusions is sewn around the perimeter except for three openings for the cables to exit. Retrofitting this system requires disassembling the cam VG cable at the cam VG lever (near the crossbar junction) and at the front pulley block shackle and sliding the pad into position.
- 2) An alternate velcro configuration is provided for retrofit pad sets which can be installed without tools. The best and most secure fit is obtained if the pads are installed with the glider assembled and the VG system activated. If you do not request option 1, we will send you this configuration.

To request your free pad set, please contact Wills Wing and provide your glider serial number.
