Applies To

All Free Flight Enterprises emergency reserve parachutes.

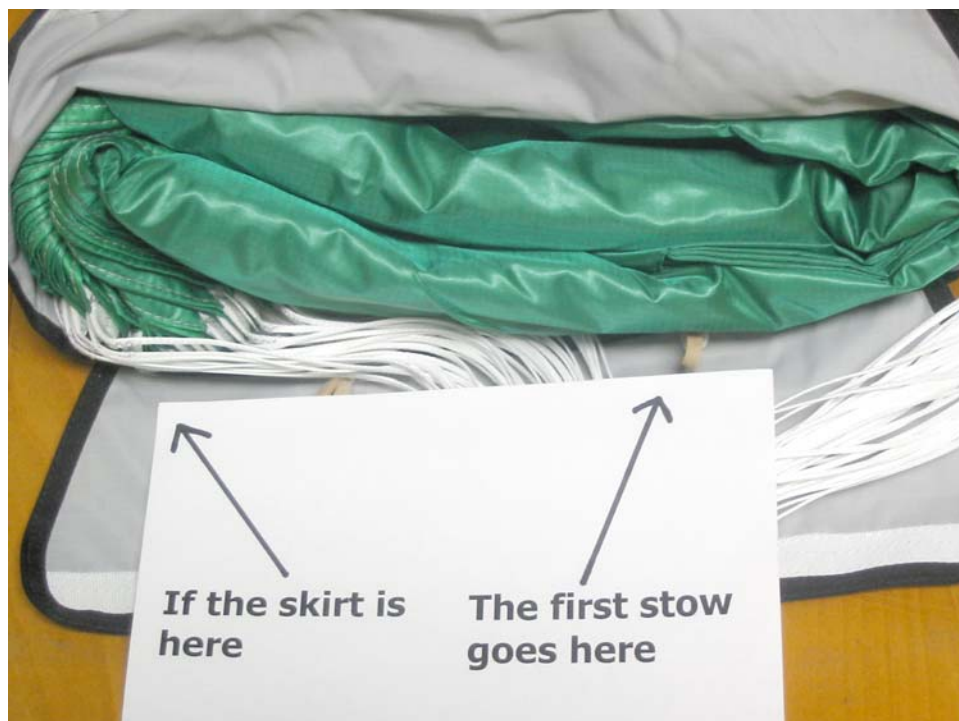
A practice parachute deployment showed a potential deployment problem with Free Flight emergency reserve parachutes. If the canopy skirt is at the side of the deployment bag, and you make the first line stow in the grommet closest to the skirt, it is possible to have a few lines stay in the rubber band while the rest of the lines pull on the skirt of the canopy. The lines pulling on the skirt then make the skirt push on the deployment bag flap, which causes the rubber band to get tighter on the lines still in the stow. This in turn causes a higher than optimum force to get the canopy out of the deployment bag. It is critical that all the lines come out of the last rubber band stow before any lines can pull on the skirt. There is a lower likelihood of this problem on the Lara Gold series of parachutes because the lines are thinner and more slippery than the nylon lines used on all other Free Flight Enterprises parachutes.

- 1) **If the skirt is at a corner of the deployment bag, make the first line stow in the grommet that is furthest from the skirt of the canopy, OR**
- 2) **Pack the canopy so that the skirt ends up in the middle of the deployment bag opening .**
