**Revised 1/14/94 Destroy all previous copies**

All layflat hardware style gliders (including the RamAir) utilizing the keel track / slider control bar apex system.

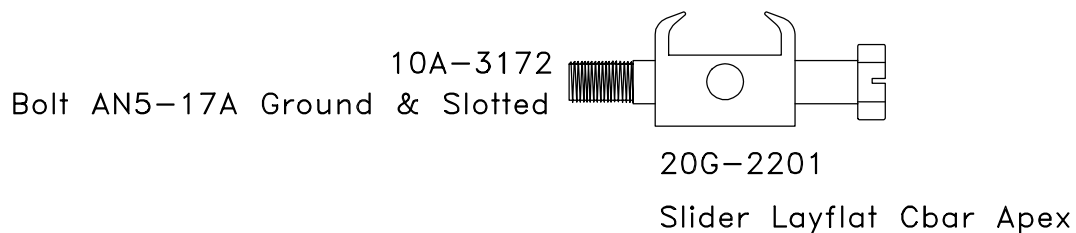
## OLD STYLE

In November, 1993 there was a design change to the control bar apex slider. The purposes of the design change were to improve the slider's resistance to damage in hard landings, to improve the retention in the slider of the plastic glide strips, and to reduce the chance of fatigue on the swan wire where it exits the front of the slider. The new slider is wider, increasing the thickness of the upper ears, and making them less likely to bend open as a result of a hard landing impact transmitted through the control bar. The new slider is extended in the front so that the slider contacts the stop bolt directly instead of via the edge of the plastic glide strip, and the slider now has a retaining slot in the front for the bottom plastic glide strip. Finally, the exit hole for the swan wire is extended and has an internal radius to reduce the chance of wire fatigue.

The new style slider, because it is wider, requires a longer bolt (see diagram above). If you are replacing a swan wire on an early model (manufactured before November of 1993) you must also order a new, longer bolt, as shown above.
